Naval Surface Warfare Center Carderock Division

NSWCCD-50-TR-2007/030 June 2007

Hydromechanics Department Report

Experiment to Characterize Sea Fighter FSF-1 Wave Slamming

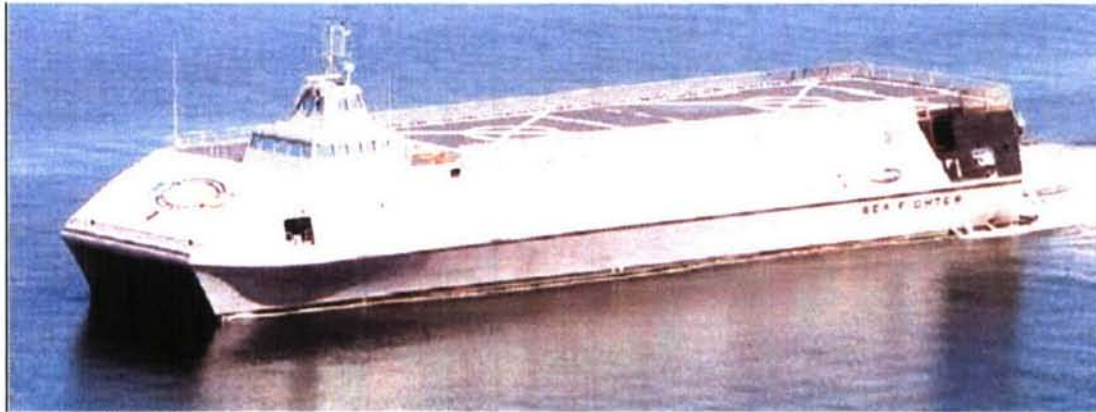
Figure 1. Photograph of *Sea Fighter*.

The *Sea Fighter* (see Figure 1 and Figure 2) is a high-speed experimental vessel, developed by the Office of Naval Research. Ship details are listed in Table 1. Christened in 2005, she is an aluminum catamaran with both diesel engines and gas turbines. Utilizing diesel engines she is capable of +20 knots. Utilizing gas turbines the ship is capable of +50 knots in calm seas. The *Sea Fighter* has four steerable Kamewa water jets. Additionally, the *Sea Fighter* has an installed "science package" of strain gauges, accelerometers, pressure gauges, and underwater viewing windows. The *Sea Fighter* was tested 18-21 April 2006 during a transit from Port Angeles, WA to San Diego, CA. Figure 3 shows a rough sketch of the course taken during the trial. The half circle and rectangular path shown south of the Oregon/California border was conducted for the purpose of collecting data at a variety of headings relative to the waves. These data were part of rough water seakeeping testing and will not be discussed in this report. Maneuvering and seakeeping data from this trial and previous trials were documented by NSWCCD, Code 5500.

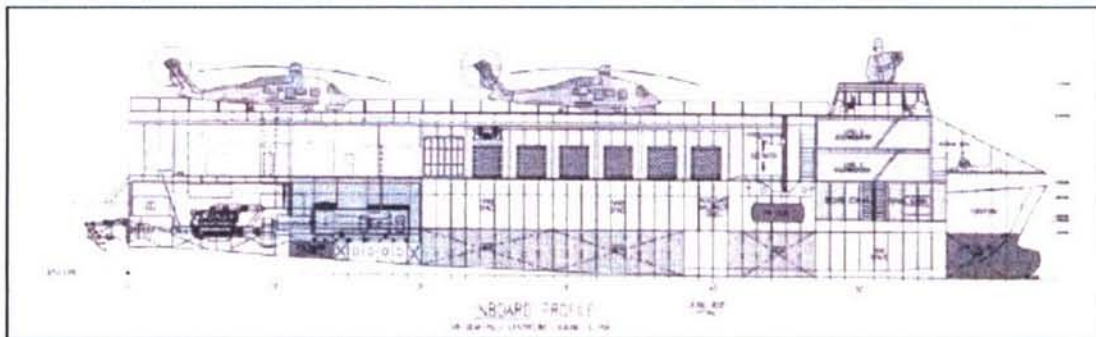
Figure 2. Ship drawing of *Sea Fighter*.

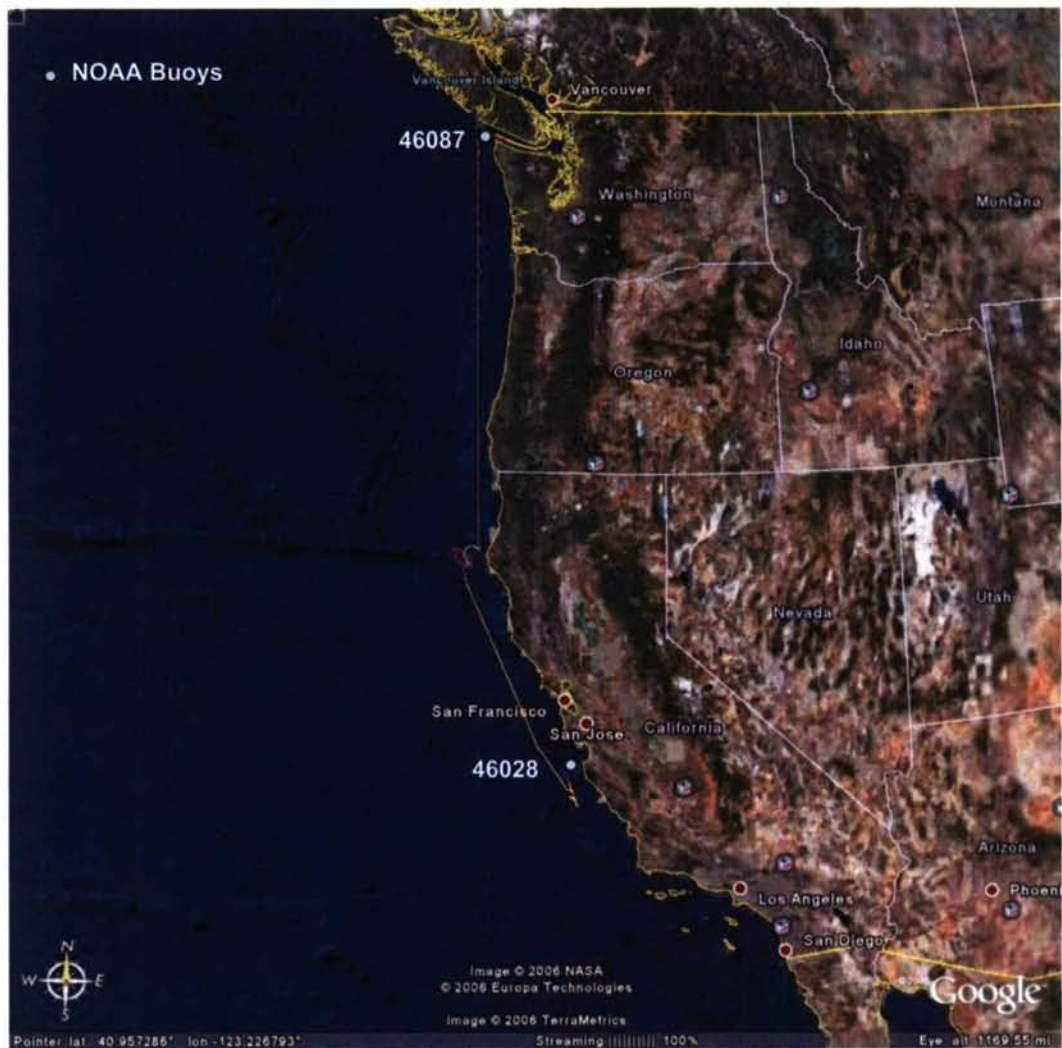
Figure 3. *SeaFighter* course during trial.

** NOAA buoy located at 35.75N, 121.89W - 30 to 40 nm NE maneuvering hexagon (see Figure 3)

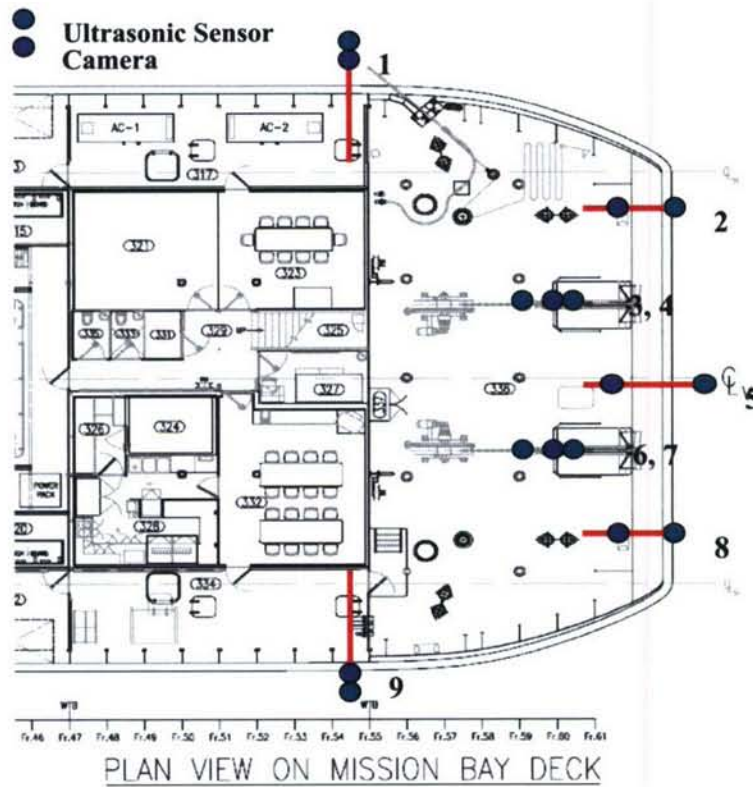
Figure 4. Diagram of bow ultrasonic and camera locations.

Thirteen Senix ToughSonic distance sensors were used to measure the level of the free-surface at various locations around the vessel. An ultrasonic wave height transducer emits and receives the reflection of an acoustic signal. The time between the emission and receipt of the pulse allows for the calculation of the distance between the probe and the free-surface of the water. The probes have a 15 degree spread angle, meaning they average the signal received from a rather large patch of water, depending on the distance to the water surface itself. The sensors on board the *Sea Fighter* were mounted approximately 15-20 ft from the water surface. The sensors have a 10 Hz sampling rate, a range of 10 in to 30 ft, with an accuracy of 0.05 in. Figure 4 shows the location of the underway cameras and ultrasonic sensors, which were collocated at each of seven locations around the bow of the vessel. Table 2 lists the longitudinal and transverse locations of the bow sensors relative to the forward most bulkhead and vessel centerline. Sensors 3, 4, 6, and 7 and their associated cameras were mounted in the forward anchor wells as shown, while the remaining sensors were mounted off booms from the forecastle deck. Four additional sensors were deployed around the stern (two at the front of the boat ramp in the tunnel and two at the aft end). Data from the sensors and cameras were collected the entire time the ship was at sea.

* referenced BHD is BHD at frame 55 (see Figure 4)

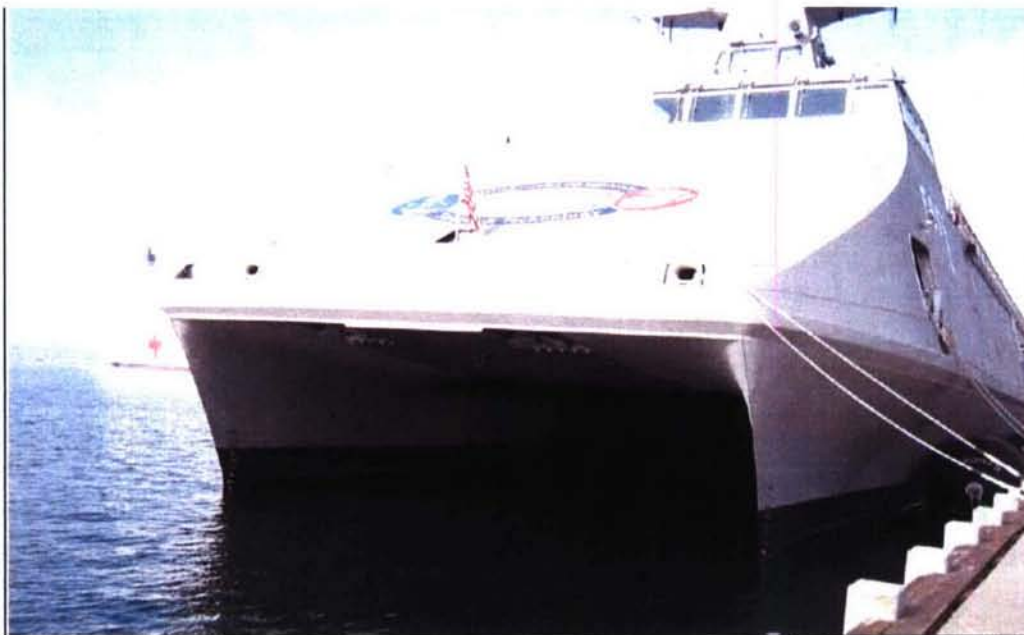
Figure 5. View of the *Sea Fighter* hatch opening at the bow.
The forward LIDAR tower was mounted to the anchor deck beneath the hatch, and extended out its opening.

The forward LIDAR tower was 20 ft in length and was comprised of standardized 55G steel radio mast sections. It was located as far forward as possible onboard on the *Sea Fighter* to provide the necessary look angles for operation of the fixed and scanning LIDAR units. It stood approximately 35 ft above the water surface. The tower was mounted to the anchor deck directly underneath the forward hatch opening (near the flagpole). This location was required to allow the measurement of the free-surface as close as possible to the ship's bow (Figure 5 and Figure 6). The hatch is very near the centerline of the vessel. The tower also had guy wires to existing tie down points located on the *Sea Fighter*. A 2 ft x 2 ft 6061 AL baseplate was welded to the anchor deck directly beneath the hatch opening to provide a secure mount for the tower. The LMS-Q140 LIDAR was mounted on top of a pan/tilt unit at the top of the tower. The pan/tilt unit controlled the orientation of the LIDAR and could be operated remotely. The LIDAR was oriented to scan a swath parallel to the ship's bow (Figure 7); it was tilted 30 degrees downward such that it could see the free-surface, approximately 15 ft forward of the bow. The swath width was approximately 69 ft; the spatial resolution was 1 in. The second LIDAR, LMS-Q240, was mounted below the LMS-Q140, and fixed such that its swath was perpendicular to the bow and tilted approximately 45 degrees downward (Figure 8), and the swath width was 111 ft. The spatial resolution was 0.2 in. The tower also contained the third LIDAR unit, LD90-3800EHS-FLP, which provided a single point measurement. It was tilted approximately 13 degrees downward from vertical and had a spatial resolution of 2 in. The system was operated to provide single point time series of water surface elevation forward of the vessel, at the centerline. Figure 9 shows a photograph of the LIDAR tower on the *Sea Fighter*. Figure 10 illustrates the locations of the LIDAR and WaMoS towers. The data collected by the LIDAR system were not collected by NSWCCD and therefore will not be discussed in this report.

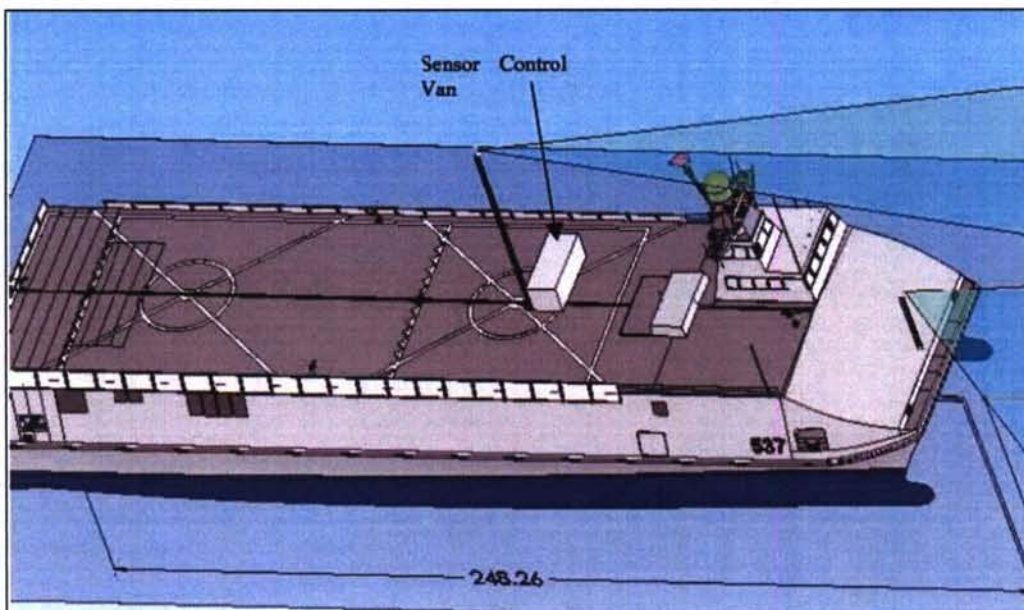
Figure 6. Drawing of the *Sea Fighter* showing locations of the forward LIDAR tower, the x-band tower, and sensor control van.
The x-band tower is directly aft of the equipment van, approximately 17 ft aft of the elevator. Units in the diagram are in feet.

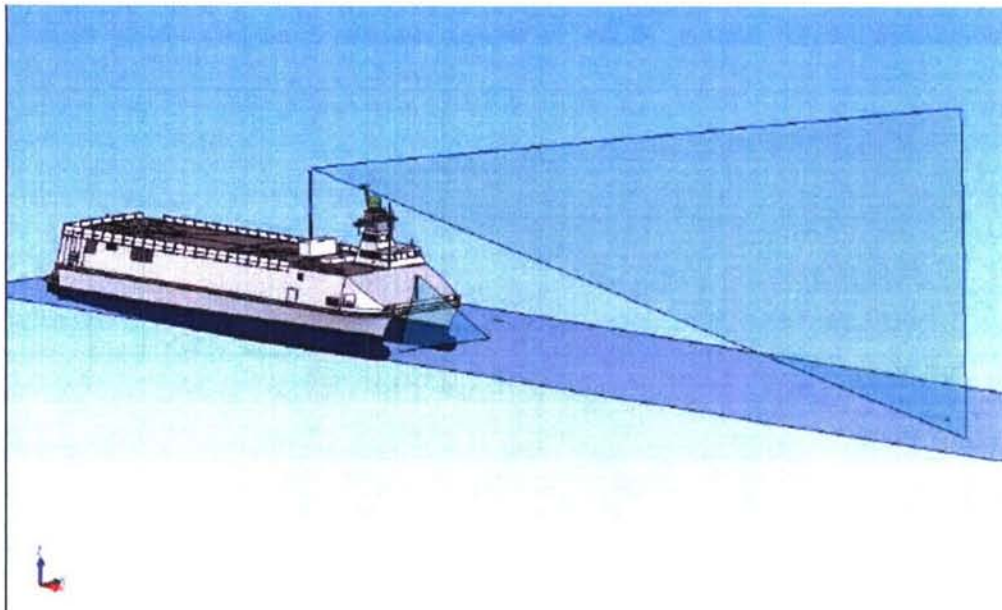
Figure 7. View of the forward LIDAR tower (with the LMS-Q140s scan swath) and the x-band tower (with the WaMoS II's scan beam). Not shown is the vertical scanning LIDAR swath.

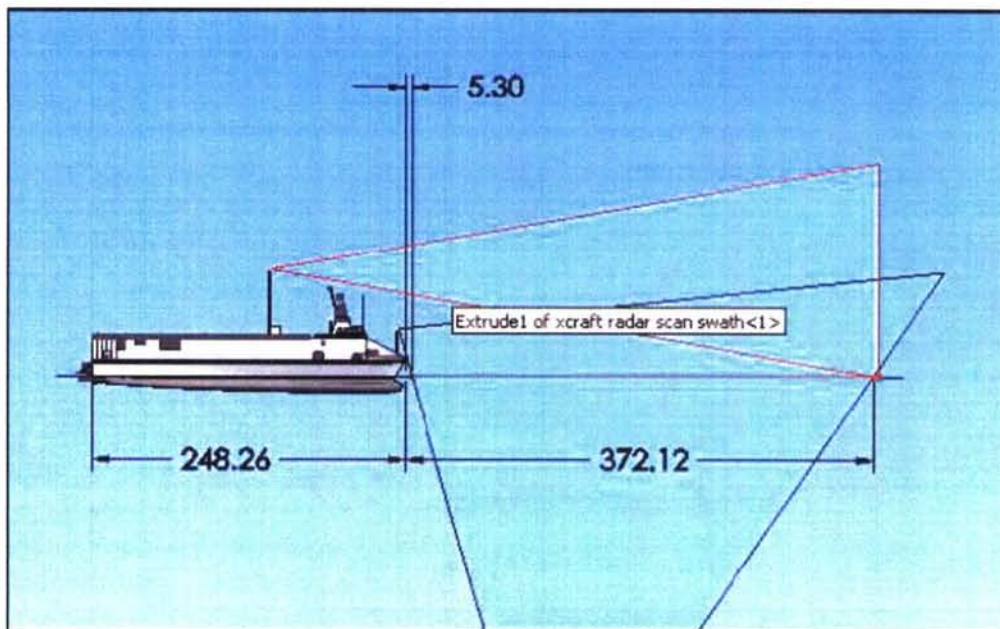
Figure 8. Side view of the *Sea Fighter* and instrumentation towers. This figure shows the length of the ship; distance from bow to the LMS-Q240 LIDARs swath (5.30 ft); and distance from bow to the x-band field-of-view (372.12 ft). All units in diagram are in feet.

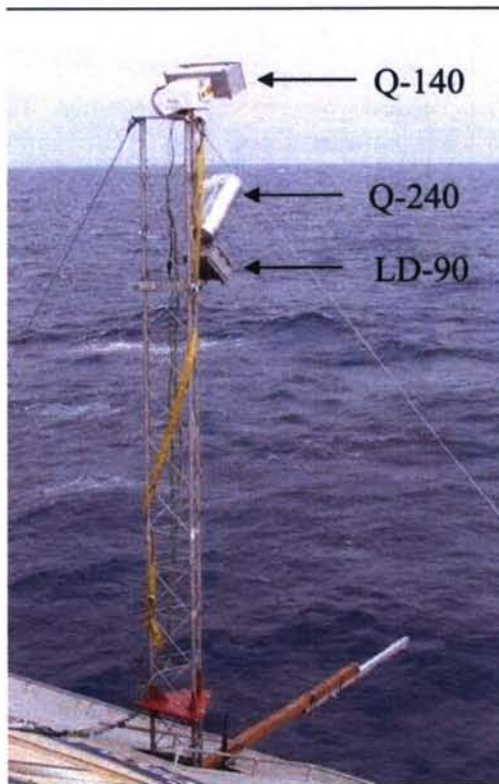
Figure 9. Photo of LIDAR tower on the *Sea Fighter*.

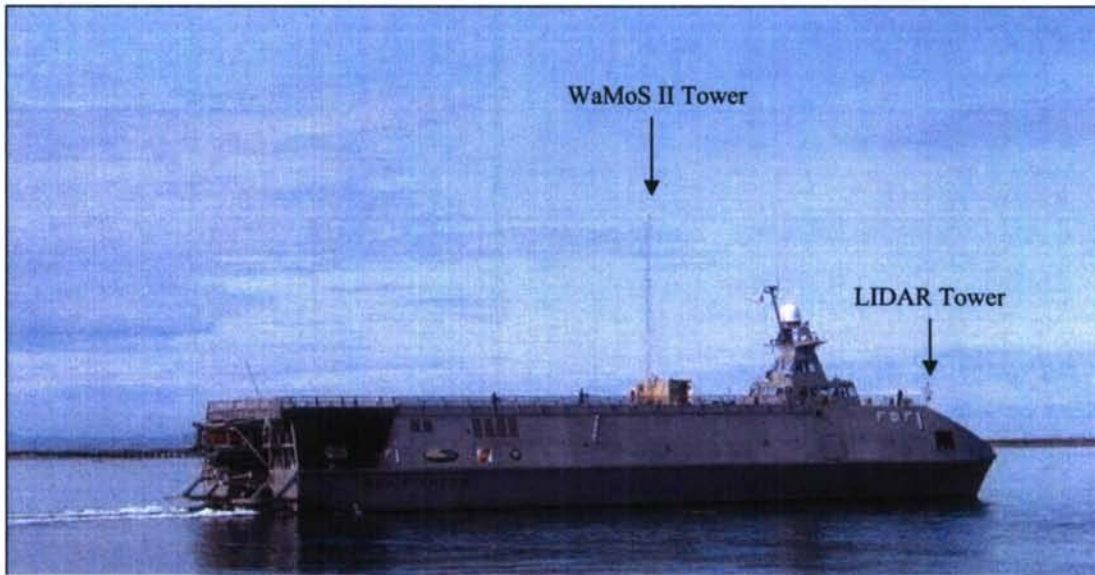
Figure 10. LIDAR and WaMoS (x-band radar) tower locations.

obstructed by any parts of the ship in all directions, the x-band tower stood 60 ft high and approximately 90 ft above the water surface so that it did not get returns from the existing superstructure onboard *Sea Fighter*. When looking forward, it viewed the sea surface approximately 372 ft forward of the ship's bow. The supporting electronics and computing resources for the x-band wave measurement system resided within the sensor control van directly beneath the tower. Figure 10 shows the location of the WaMoS-II and LIDAR towers onboard the *Sea Fighter*. Figure 11 is a photograph of the tower aboard the *Sea Fighter* during the test. The WaMoS data were not collected and analyzed by NSWCCD and will not be discussed in this report.

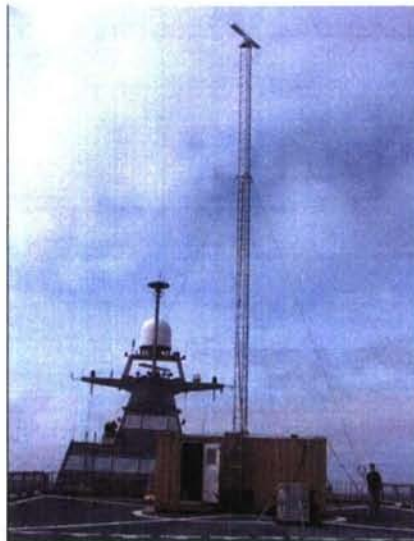
Figure 11. Photograph of x-band radar tower during testing.

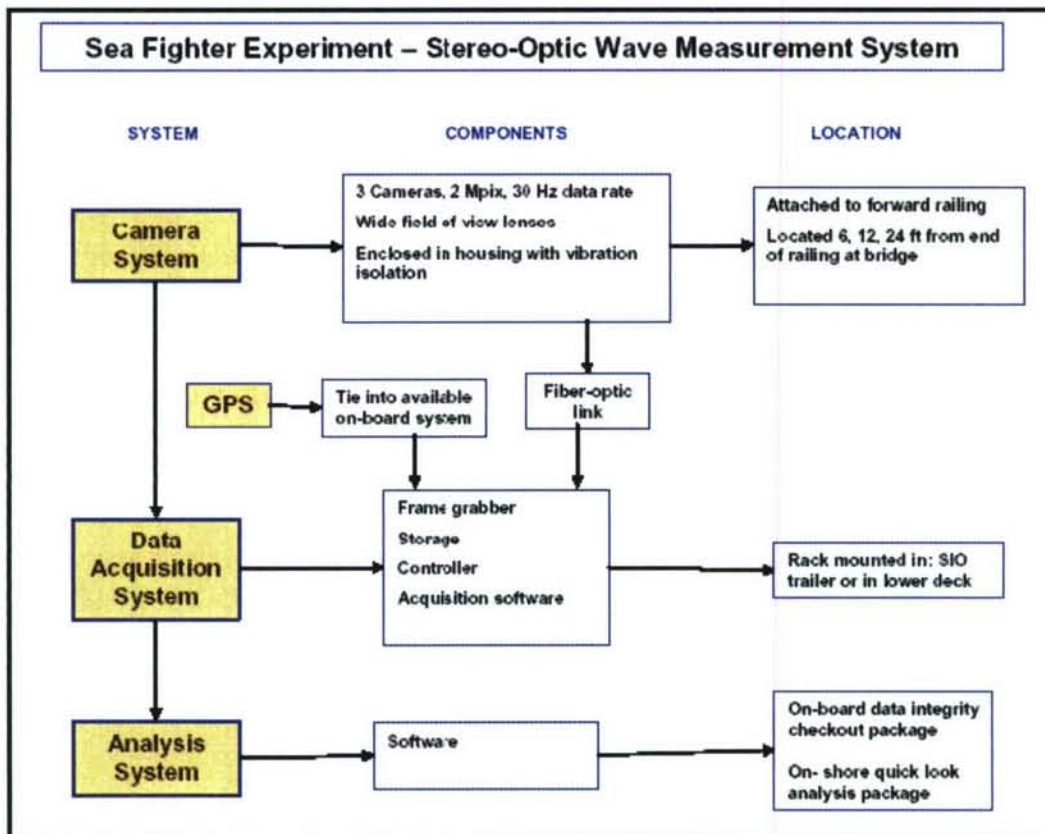
Figure 12. Schematic of the Stereo-Optic Wave Measurement System.

The overall Stereo-optic (S-O) system is schematically shown in Figure 12. A schematic of the camera-data acquisition-storage system is shown in Figure 13. The data acquisition system was tied into the available shipboard GPS time and position data stream to provide for synchronization of independent measurements and information for subsequent analysis. A three-camera system was used to provide two different S-O angles as well as a degree of redundancy. The camera/lens system was positioned to provide wave height measurements over a region nominally as wide as the ship and to cover distances forward of the bow ranging from 60 ft to as far as the wave fronts can be discerned. A schematic of the camera field-of-view is shown in Figure 14. Figure 15 provides details of the field-of-view geometry. The cameras were mounted on the forward deck, attached to the railing as shown in Figure 16. The cameras were mounted in housings, shown in Figure 17. The spacing of the cameras was determined by a trade-off between the need for accuracy of three-dimensional (3D) position determination requiring large spacing and the need to be able to identify specific discrete points in the field-of-view of each camera pair, requiring small camera separation. The highly accurate cameras acquired allow for 3D accuracy at relatively small separations.

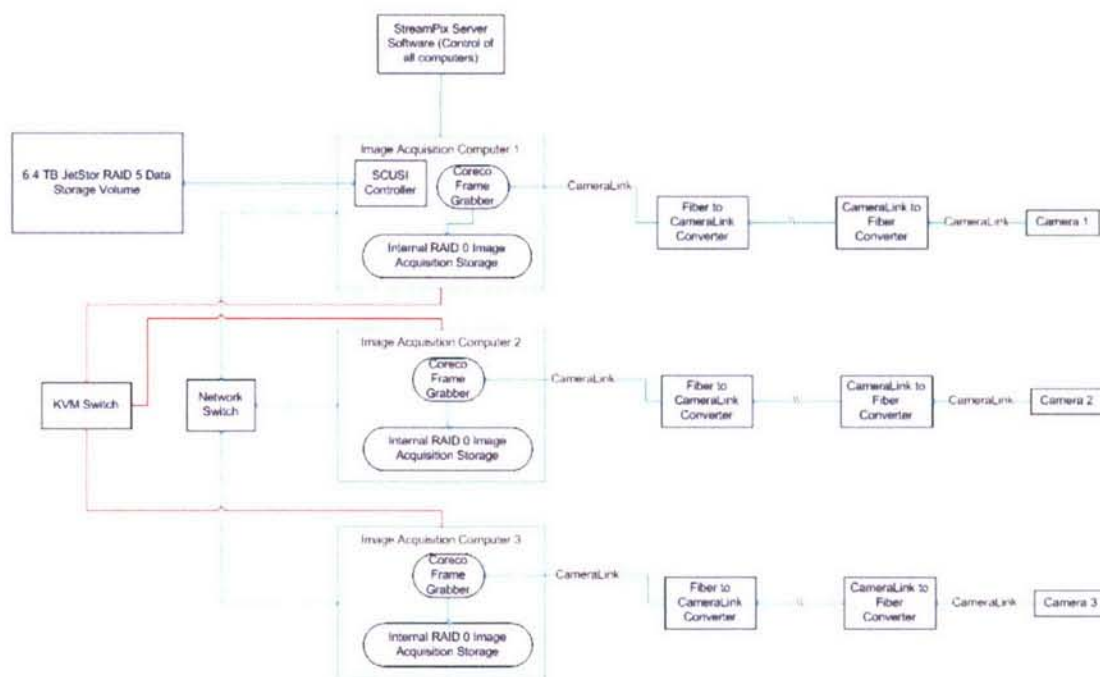
Figure 13. Schematic of the Image/Data Acquisition System.

The overall image acquisition system is shown in Figure 13. Three separate, but time synchronized image acquisition systems were used. Each system is composed of camera housing, a fiber optic cable, and a data acquisition computer. The camera housing accommodates a two mega pixel camera, a power supply, and a fiber optic converter. Fiber optic cabling connects the camera housing to the data acquisition computer. The nominal distances between each camera, from left to right is 6 ft and 12 ft (see Figure 16). The end cameras comprised the primary image acquisition system. The middle camera was included as a backup system and a supplemental source of data. The cameras within the camera housing were aligned so that the baseline between the three cameras was collinear. The cameras also had a depression angle of 17 degrees so the field-of-view just encompassed the bow of the ship.

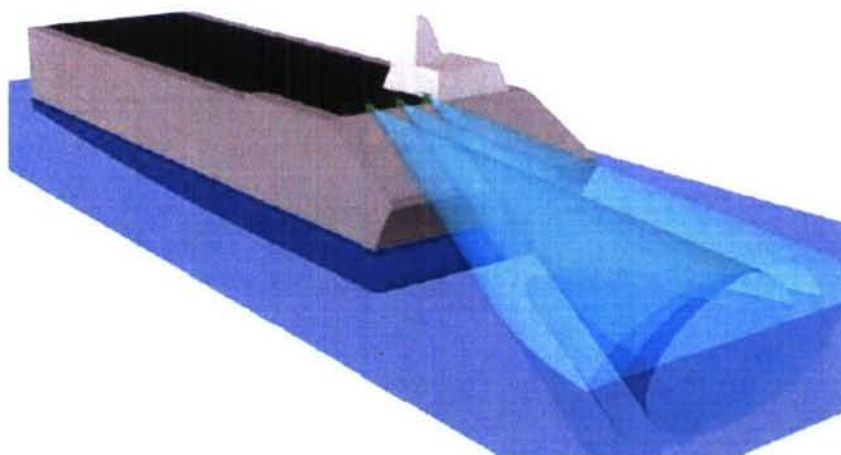
Figure 14. Schematic of stereo-optic system camera field of view.

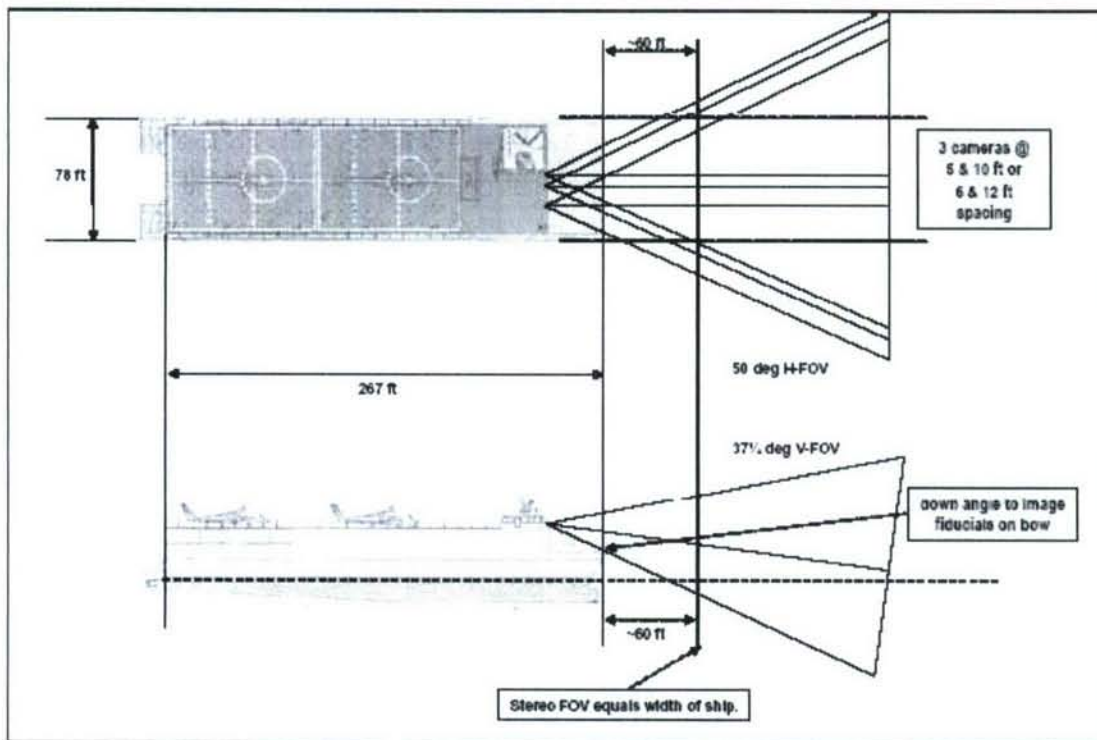
Figure 15. *Sea Fighter* Imaging Geometry.

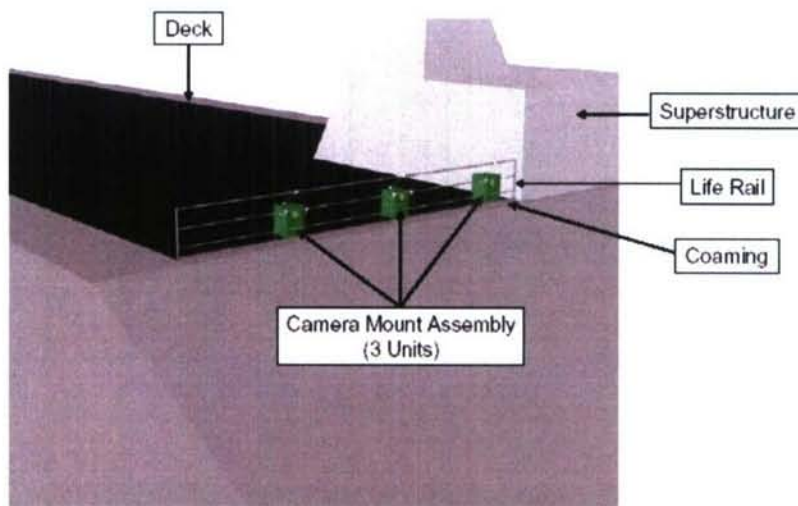
Figure 16. Camera deck arrangement.

The image acquisition computers were located in the Mission Bay. Fiber optic cables linked the cameras through a plate that allowed cables to go from the Flight Deck to the Mission Bay. The computers were rack mounted in 2-12U SKB shock absorbing rack mount containers. Rack mounted equipment also included a 6.4 TB RAID Storage and an uninterruptible power supply (UPS) for power protection and stability. The power for the cameras and fiber link converters was run from the UPS to the camera housings. In total there were three cameras acquiring data and each camera had a dedicated computer with a Coreco X64-CL-iPro PCI-X framegrabber to acquire the images. Each computer also had an internal 1.2 TB RAID array for fast data acquisition. The RAID array consisted of 4-300GB hard drives in a RAID 0 (striped) configuration for maximum data transfer. StreamPix, a software package developed by Norpix, was used to drive the image acquisition process. Data were offloaded from the internal RAID drive to the 6.4 TB RAID storage drives at regular intervals after which the internal RAID drives were erased. One computer acted as a server controlling the acquisition process of all three computers. A National Instruments NI6601 timing board was used to trigger all three framegrabbers simultaneously. This insured that all images were acquired from the cameras at the exact same time. In order to maintain uniformity of the time stamp with the rest of the data taken during the test, GPS was synched to the computer's clock.

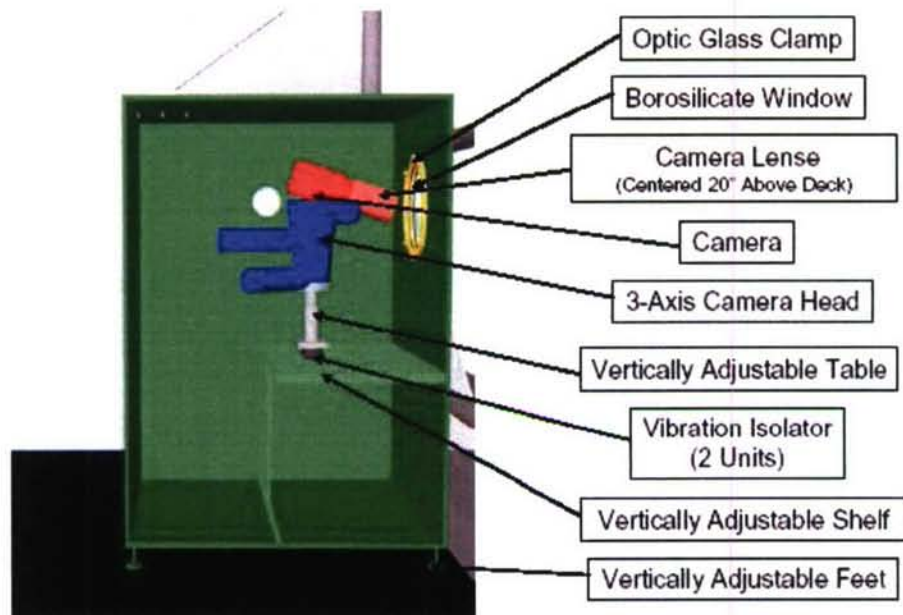
Figure 17. Camera mount arrangement.

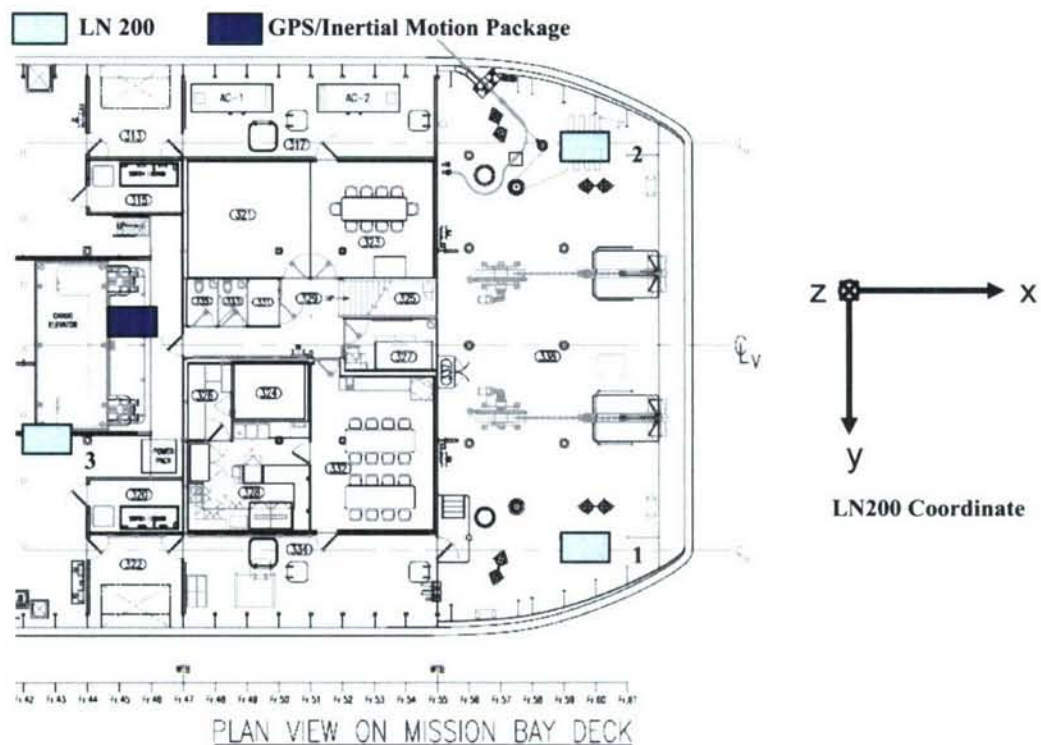
Figure 18. Locations of ship motion packages.

The combined motion package was installed near the vessel centerline and slightly aft of the second forward most watertight bulkhead as shown in Figure 18. The motion package consisted of a gyro enhanced orientation sensor (3DM-GX1), a SUPERSTAR II GPS, and a Persistor CF2 CPU. The 3DM-GX1 sensor consists of three angular rate gyros, three orthogonal DC accelerometers, three orthogonal magnetometers, and a multiplexer. The gyros track dynamic orientation while the accelerometers and magnetometers track static orientation. The 3DM-GX1 combines the static and dynamic responses in real time and records 20 samples per second. The SUPERSTAR II GPS provides position, velocity, and time data once every second. The CF2 runs on battery power and combines and stores the collected data on a flash disk. A complete list of the data recorded by this package is provided in Table 3.

centerline as shown in Figure 18. This configuration allowed for the motion of each hull and the overall ship to be examined and compared. The three LN200 inertial motion units provided linear and angular accelerations, angular rates, roll, pitch, and heading data all taken at a sampling rate of 200 Hz.

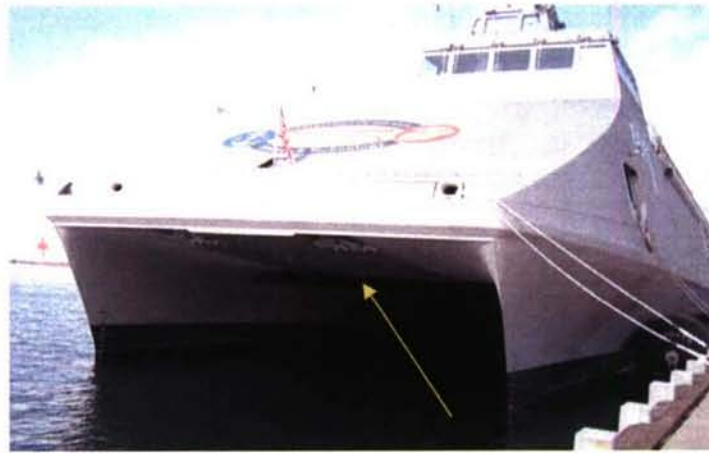
Figure 19. Schematic showing the bottom of the hull that required impact to define a slam event.

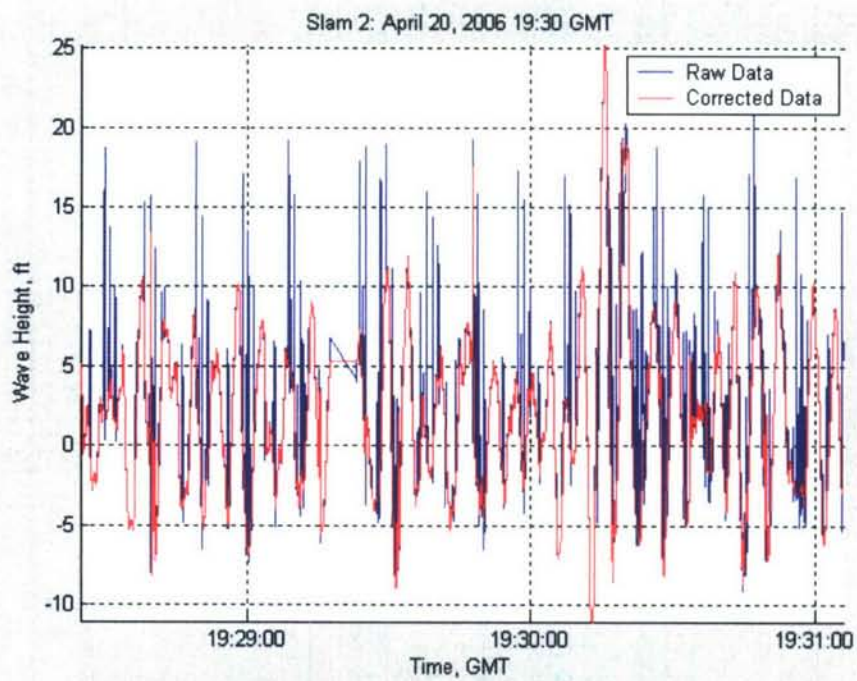
Figure 20. Example of raw and corrected ultrasonic data.

The data collected by the ultrasonic sensors was used to characterize the wave field seen by the ship before, during, and after each slam event. Due to the rough test environment (sea state 4) the data collected by the ultrasonic sensors had more signal losses than typically seen when using the instruments for experiments in the tow basin. Therefore, the raw data first needed to be filtered and the losses corrected. Signal losses were identified based on the slope between adjacent points. If the absolute value of the slope between two points was greater than a given threshold, 10 ft/msec, then those data points were flagged as part of a signal loss. The threshold was chosen based on the sea state information and instrument capabilities. Data from the ultrasonics were collected at 10 Hz, therefore, in sea state 4 conditions it is highly unlikely that a wave steepness of that magnitude could be achieved in only 0.1 seconds; that would require the wave height to change by 10 ft in only 0.1 seconds.

After a data point was flagged as part of a signal dropout its value was reset to zero. The dropouts, now zero values, were then filled in by linearly interpolating between the two nearest non-zero values (the last recorded value before the loss and the first point once reconnected). Figure 20 and Figure 21 show an example of the raw data (with dropouts) and the corrected data for the port bowline sensor for Slam Event 2. The dropouts in the raw data can be recognized as the steep vertical blue lines. The gap in the data shortly after 19:29 GMT, denoted by the flat red line is different than an ultrasonic dropout. It is caused by a loss of the time feed into the data acquisition program and is a loss of data that can not be replaced; therefore these gaps remain in the data sets while dropouts are corrected. As seen by Figure 20 and Figure 21 it was impossible to eliminate every dropout, however, the majority of dropouts were identified and corrected, producing a more complete set of data to use in analysis.

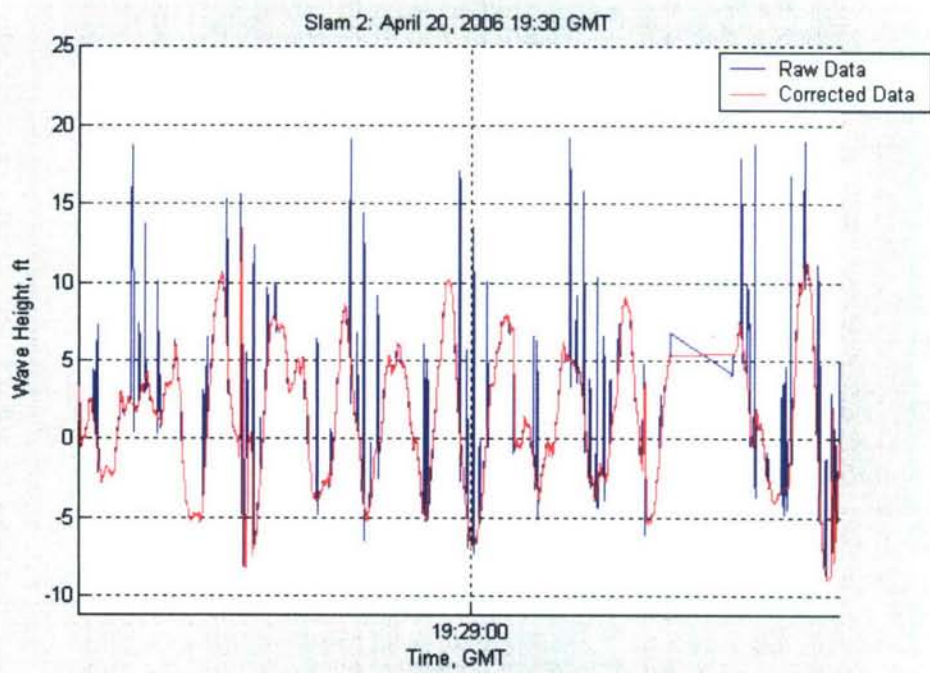
Figure 21. A zoomed in view of Figure 20.

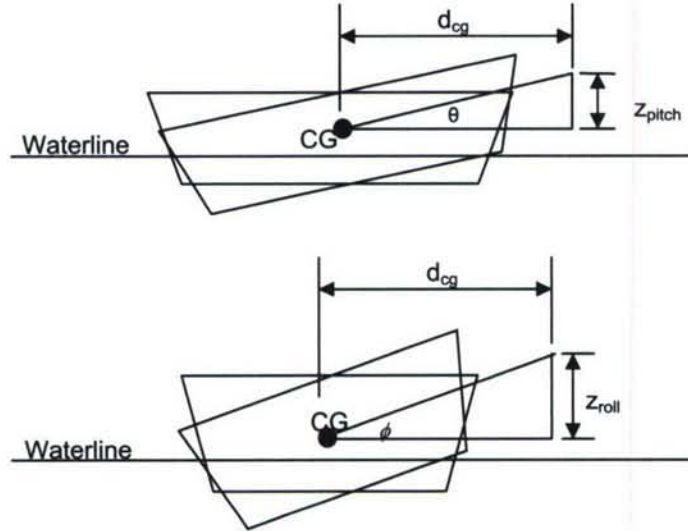
Figure 22. Diagram illustrating derivation of Equations 1 and 2.

In addition to correcting the data for signal losses the data also had to be corrected for ship motions. Motion data from LN200 package 3 was used because it was located closest to the ship CG. Given the distance of the instrument from the CG the height in the ultrasonic readings due to ship motions was determined using equations 1 and 2. This height, z_{pitch} and z_{roll} , was then removed from the ultrasonic readings. The derivation of these equations is illustrated in Figure 22.

$$z_{pitch} = d_{cg} \cdot \sin \theta \quad (1)$$

$$z_{roll} = d_{cg} \cdot \sin \phi \quad (2)$$

Where: d_{cg} = longitudinal or transverse distance to ship CG
 θ = pitch angle from LN200 3
 ϕ = roll angle from LN200 3

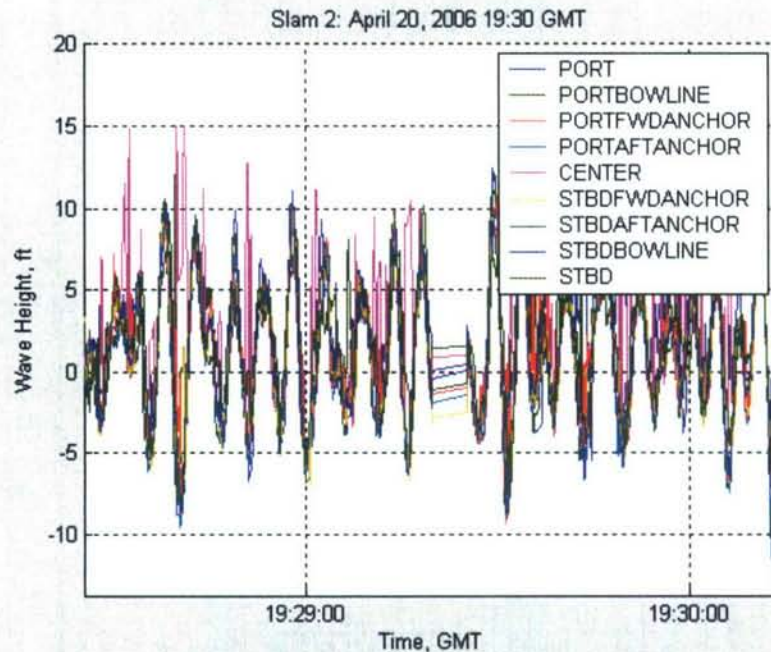
Figure 23. Plot of all bow ultrasonics for Slam Event 2.

Once the raw data were corrected the wave field was able to be determined. Figure 23 shows a portion of the corrected data for all the bow ultrasonics for Slam Event 2. In total, there were nine bow ultrasonics, (refer to Figure 6 and Table 2 for details of the ultrasonic locations) however, the starboard aft anchor ultrasonic is not included in the data set because it was damaged earlier in the test. The purple trendline is data collected by the center ultrasonic and Figure 23 shows that it still has a significant number of dropouts even after the data was processed to help eliminate the dropouts created by a signal loss. The center ultrasonic, as well as the port and starboard ultrasonics, was mounted on a boom that projected out from the front of the ship. This allowed the spread angle of the ultrasonics to not be obstructed by any part of the ship. While in rough seas, especially during a slam event, the boom itself had its own motion making it difficult to keep a continuous signal of data. It is assumed that the increase in the number of dropouts seen by these ultrasonics is due to this mounting configuration.

Based on the data shown in Figure 23 it was determined that each ultrasonic, regardless of its location along the bow of the ship saw the same wave field. Therefore, it was determined that the data collected by the center, port, and starboard ultrasonics could be omitted from further analysis without altering the final wave field characterization.

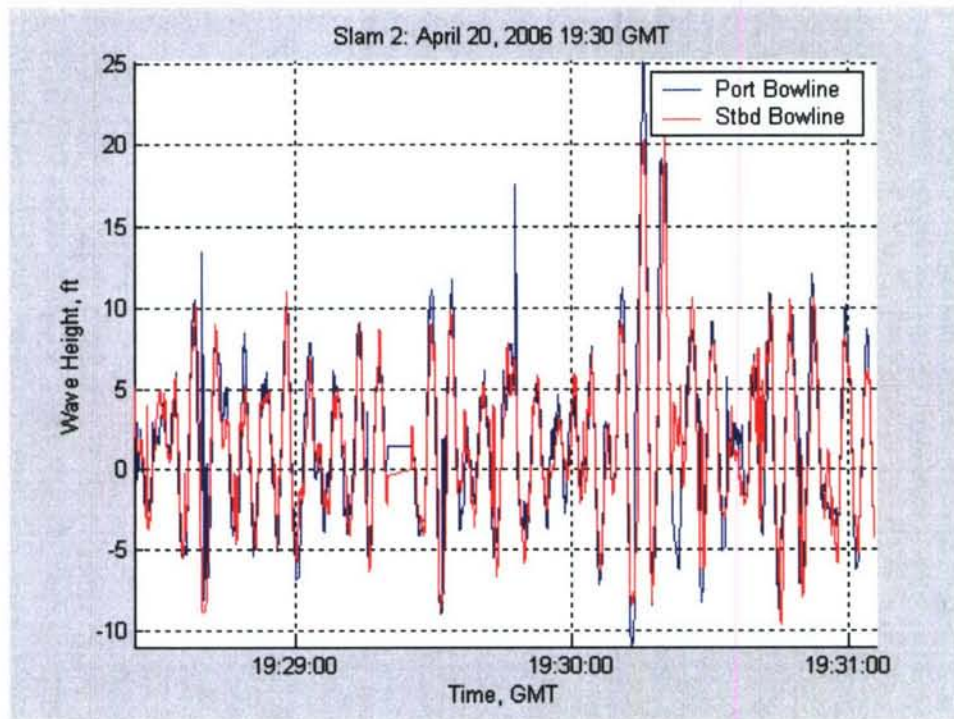
Figure 24. Slam Event 2: Bowline Ultrasonics.

Once the port, starboard, and center ultrasonics were omitted from the analysis the four sensors mounted in the anchor wells were compared to one another to determine an overall anchor well wave profile and the same analysis was applied to the port and starboard bowline sensors. Figure 24 shows the comparison of the port and starboard bowline sensors. The blue and red trendlines represent the corrected data for the port and starboard bowline sensors respectively. The figure shows that the data collected by both sensors was very similar, and therefore, an average between the two was calculated and used in determining the overall wave field during this event.

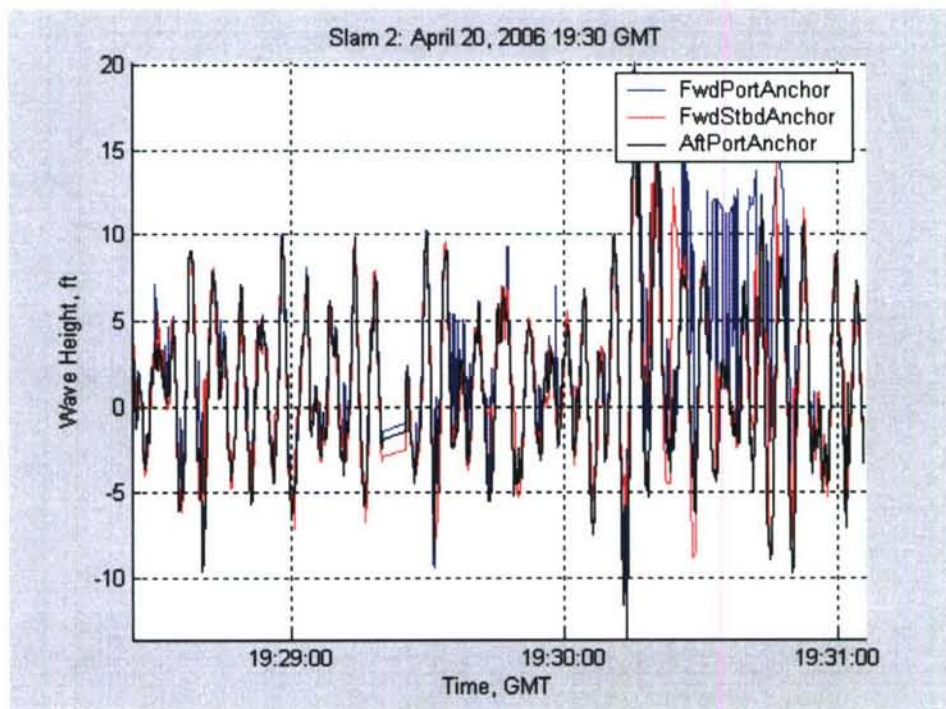
Figure 25. Slam Event 2: Anchor Well Ultrasonics.

The same approach was used in analyzing the data from the anchor well sensors. Figure 25 shows the data from the three functioning anchor well ultrasonics. All three ultrasonics show similar wave fields, however, the port forward anchor ultrasonic still has various dropouts after the slam event that were unable to be corrected. Therefore, this ultrasonic was omitted and the port aft and starboard forward ultrasonics were averaged to determine the average anchor well wave profile. The anchor well average and bowline average were then averaged to determine the overall wave field seen by the vessel before, during, and after the slam event. Figure 26 shows the anchor well and bowline averages and the final average between the two. Figure 27 shows the final wave profile for Slam Event 2.

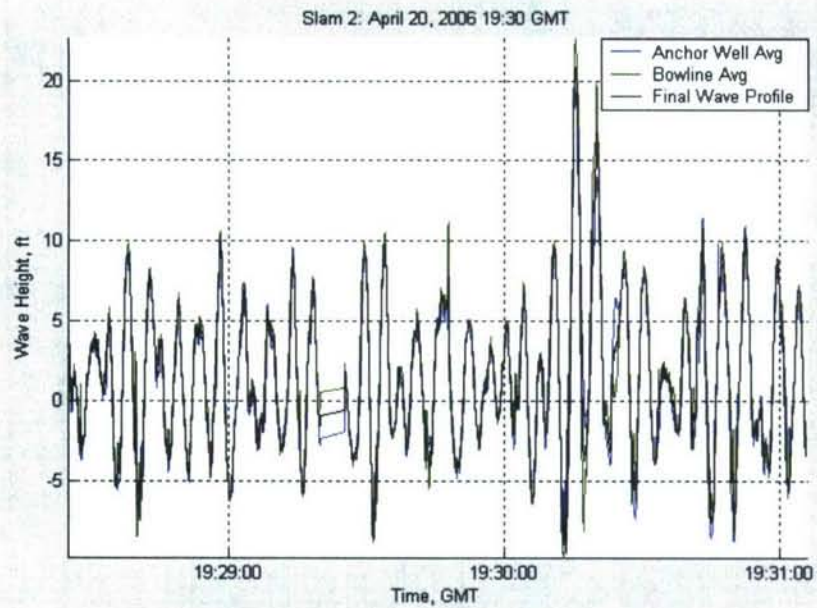
Figure 26. Slam Event 2: Anchor well average, bowline average, final wave profile.

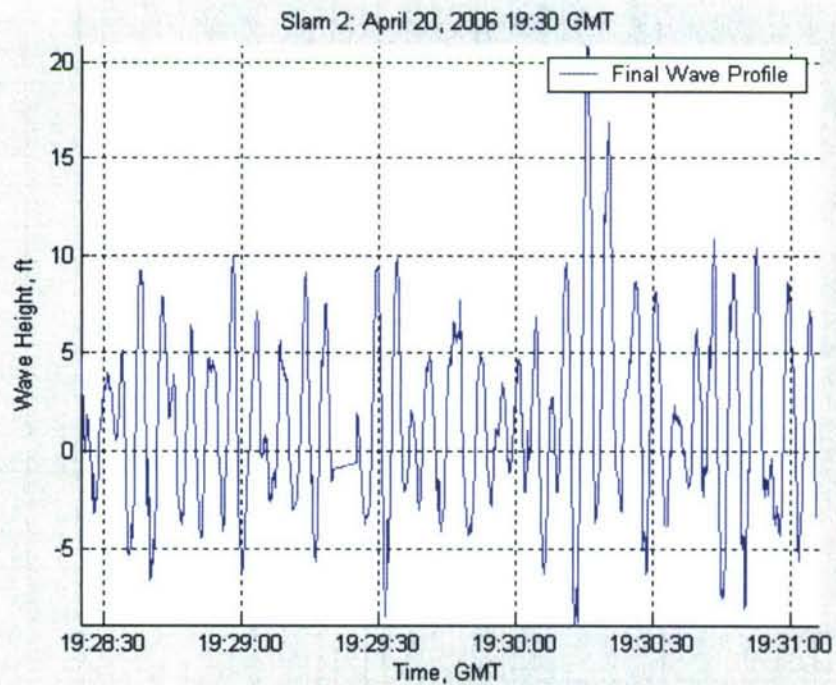
Figure 27. Slam Event 2: Final Wave Field Profile.

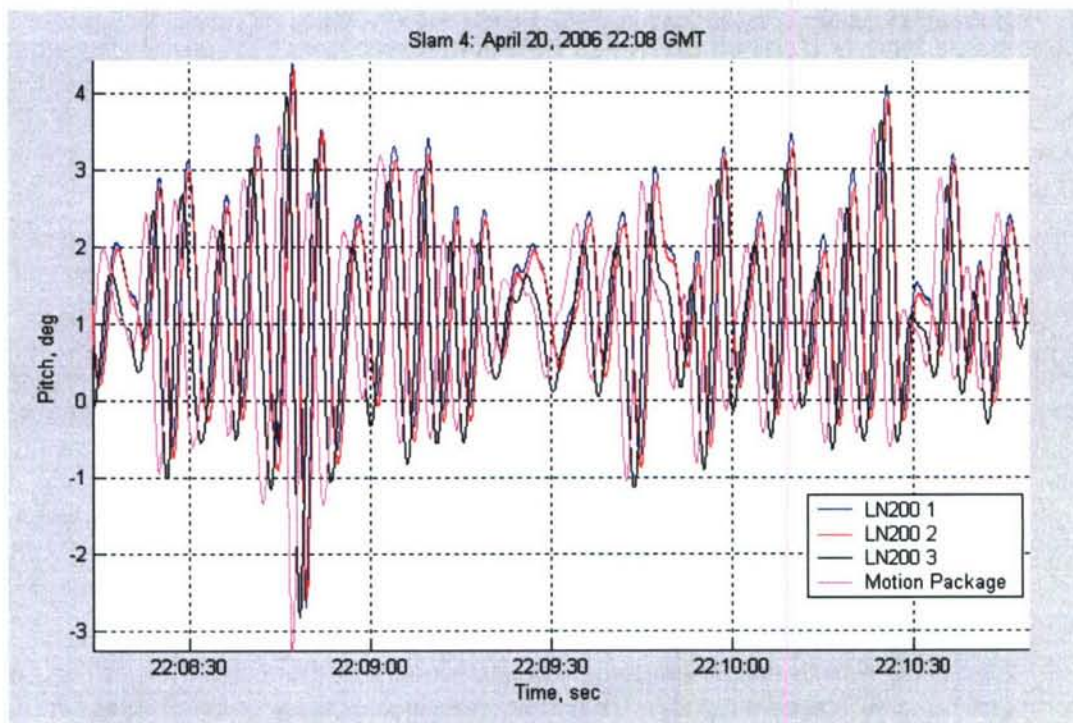
Figure 28. Pitch comparison between ship motion packages.

Ship motions were measured using two separate motion packages; a set of three Litton LN200s and a combination GPS and inertial motion package. Figure 28 shows a comparison between the three LN200s and the motion package for ship pitch during Slam Event 4. All four instruments show the same trend in the data. The data from LN200 1 and LN200 2 practically lie on top of one another and only have a small phase shift from LN200 3 which has a short lag time behind the motion package. This small variation in signal is due to the location of the instruments on board *Sea Fighter* (refer to Figure 18). LN200 1 and 2 were both roughly the same distance forward of the center of gravity and equal distances longitudinally off the vessel centerline, making the data collected by each very similar as expected. LN200 3 and the motion package were located aft of LN200 1 and 2, closer to the vessel CG; and this is reflected in their data. It is important to note that there is limited control in a full scale in situ experiment. Therefore, it is also likely that there is some roll contamination in the pitch readings and vice versa due to an inability to mount the instruments completely level which may also be a contributing factor in the variations seen in the ship motion instruments. This comparison of the motion packages was used to further validate the data collected by each instrument showing that each was functioning properly during the trial.

Some conclusions can be drawn from the comparison among the LN200s. The instruments were specifically chosen to be placed one in each of the side hulls and one near the centerline of the vessel to examine ship bending during high impacts events. The consistency throughout the slam event of the data in Figure 28 shows that no significant bending has occurred. However, due to the possibility of roll contamination and without additional instruments such as strain gages mounted in each hull, it is difficult to completely eliminate the possibility of some bending due to a slam event. Additional structural data and analysis for *Sea Fighter* will be reported by NSWCCD, Code 60.
